2134590

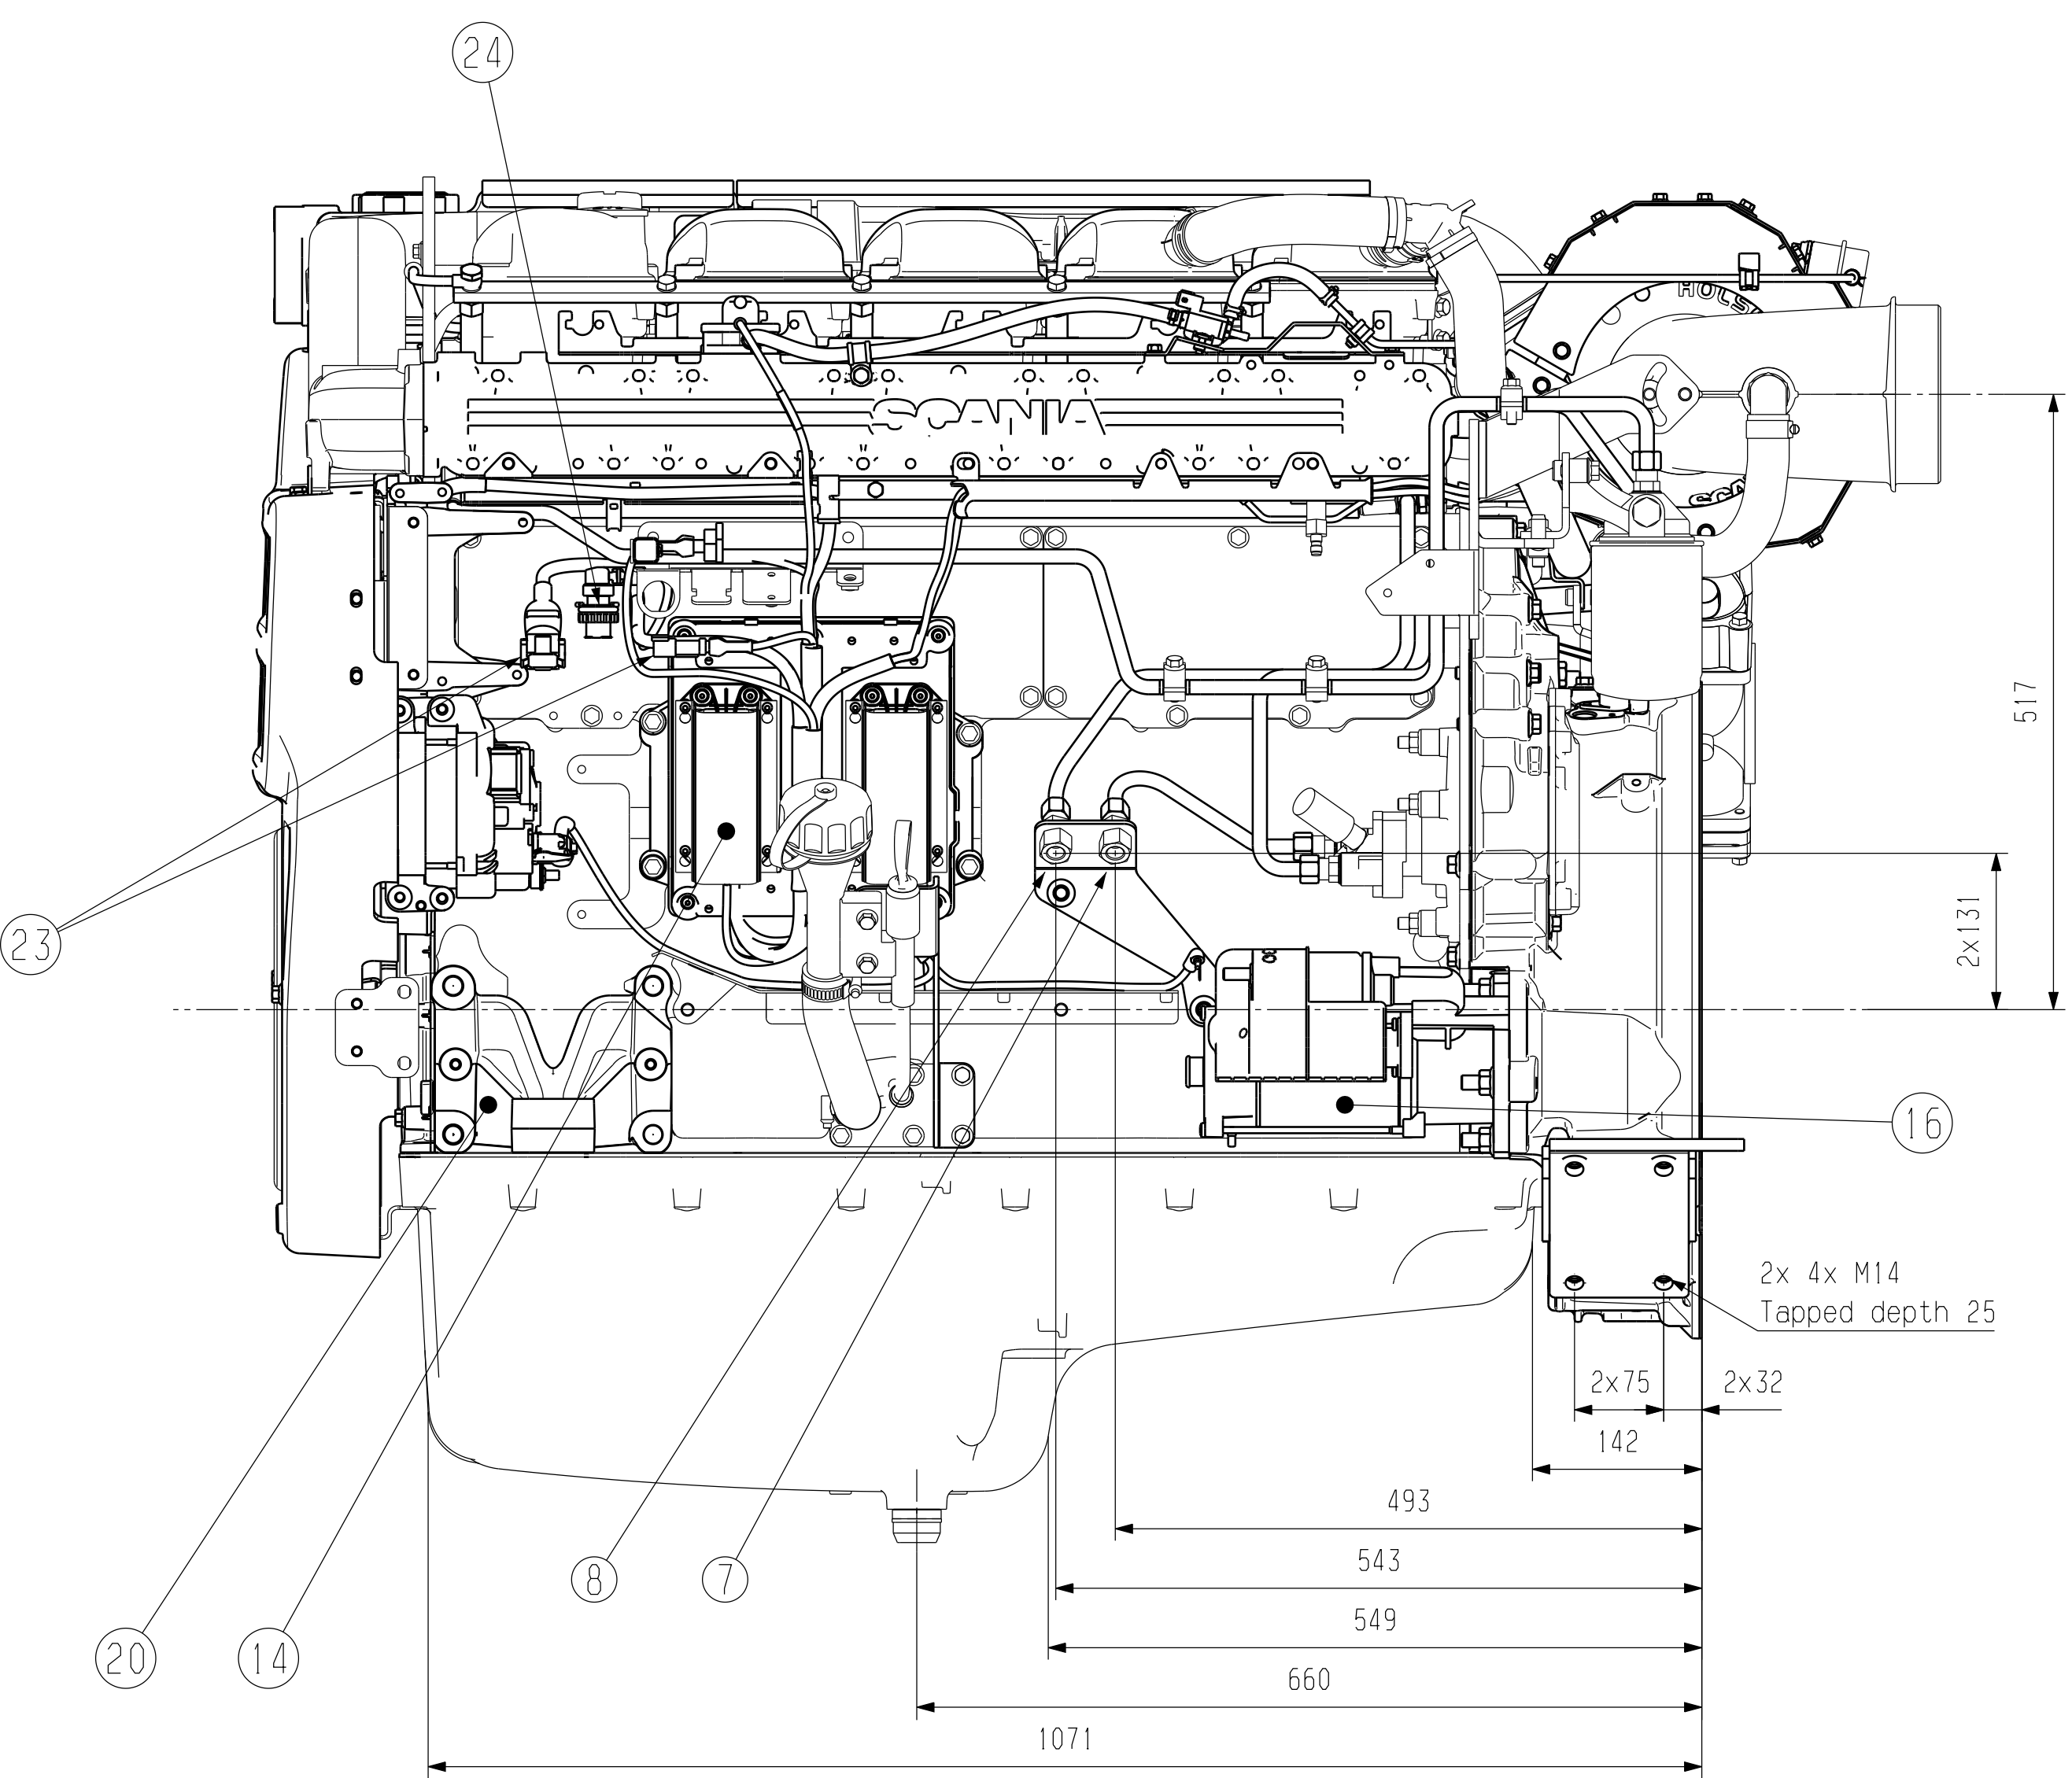
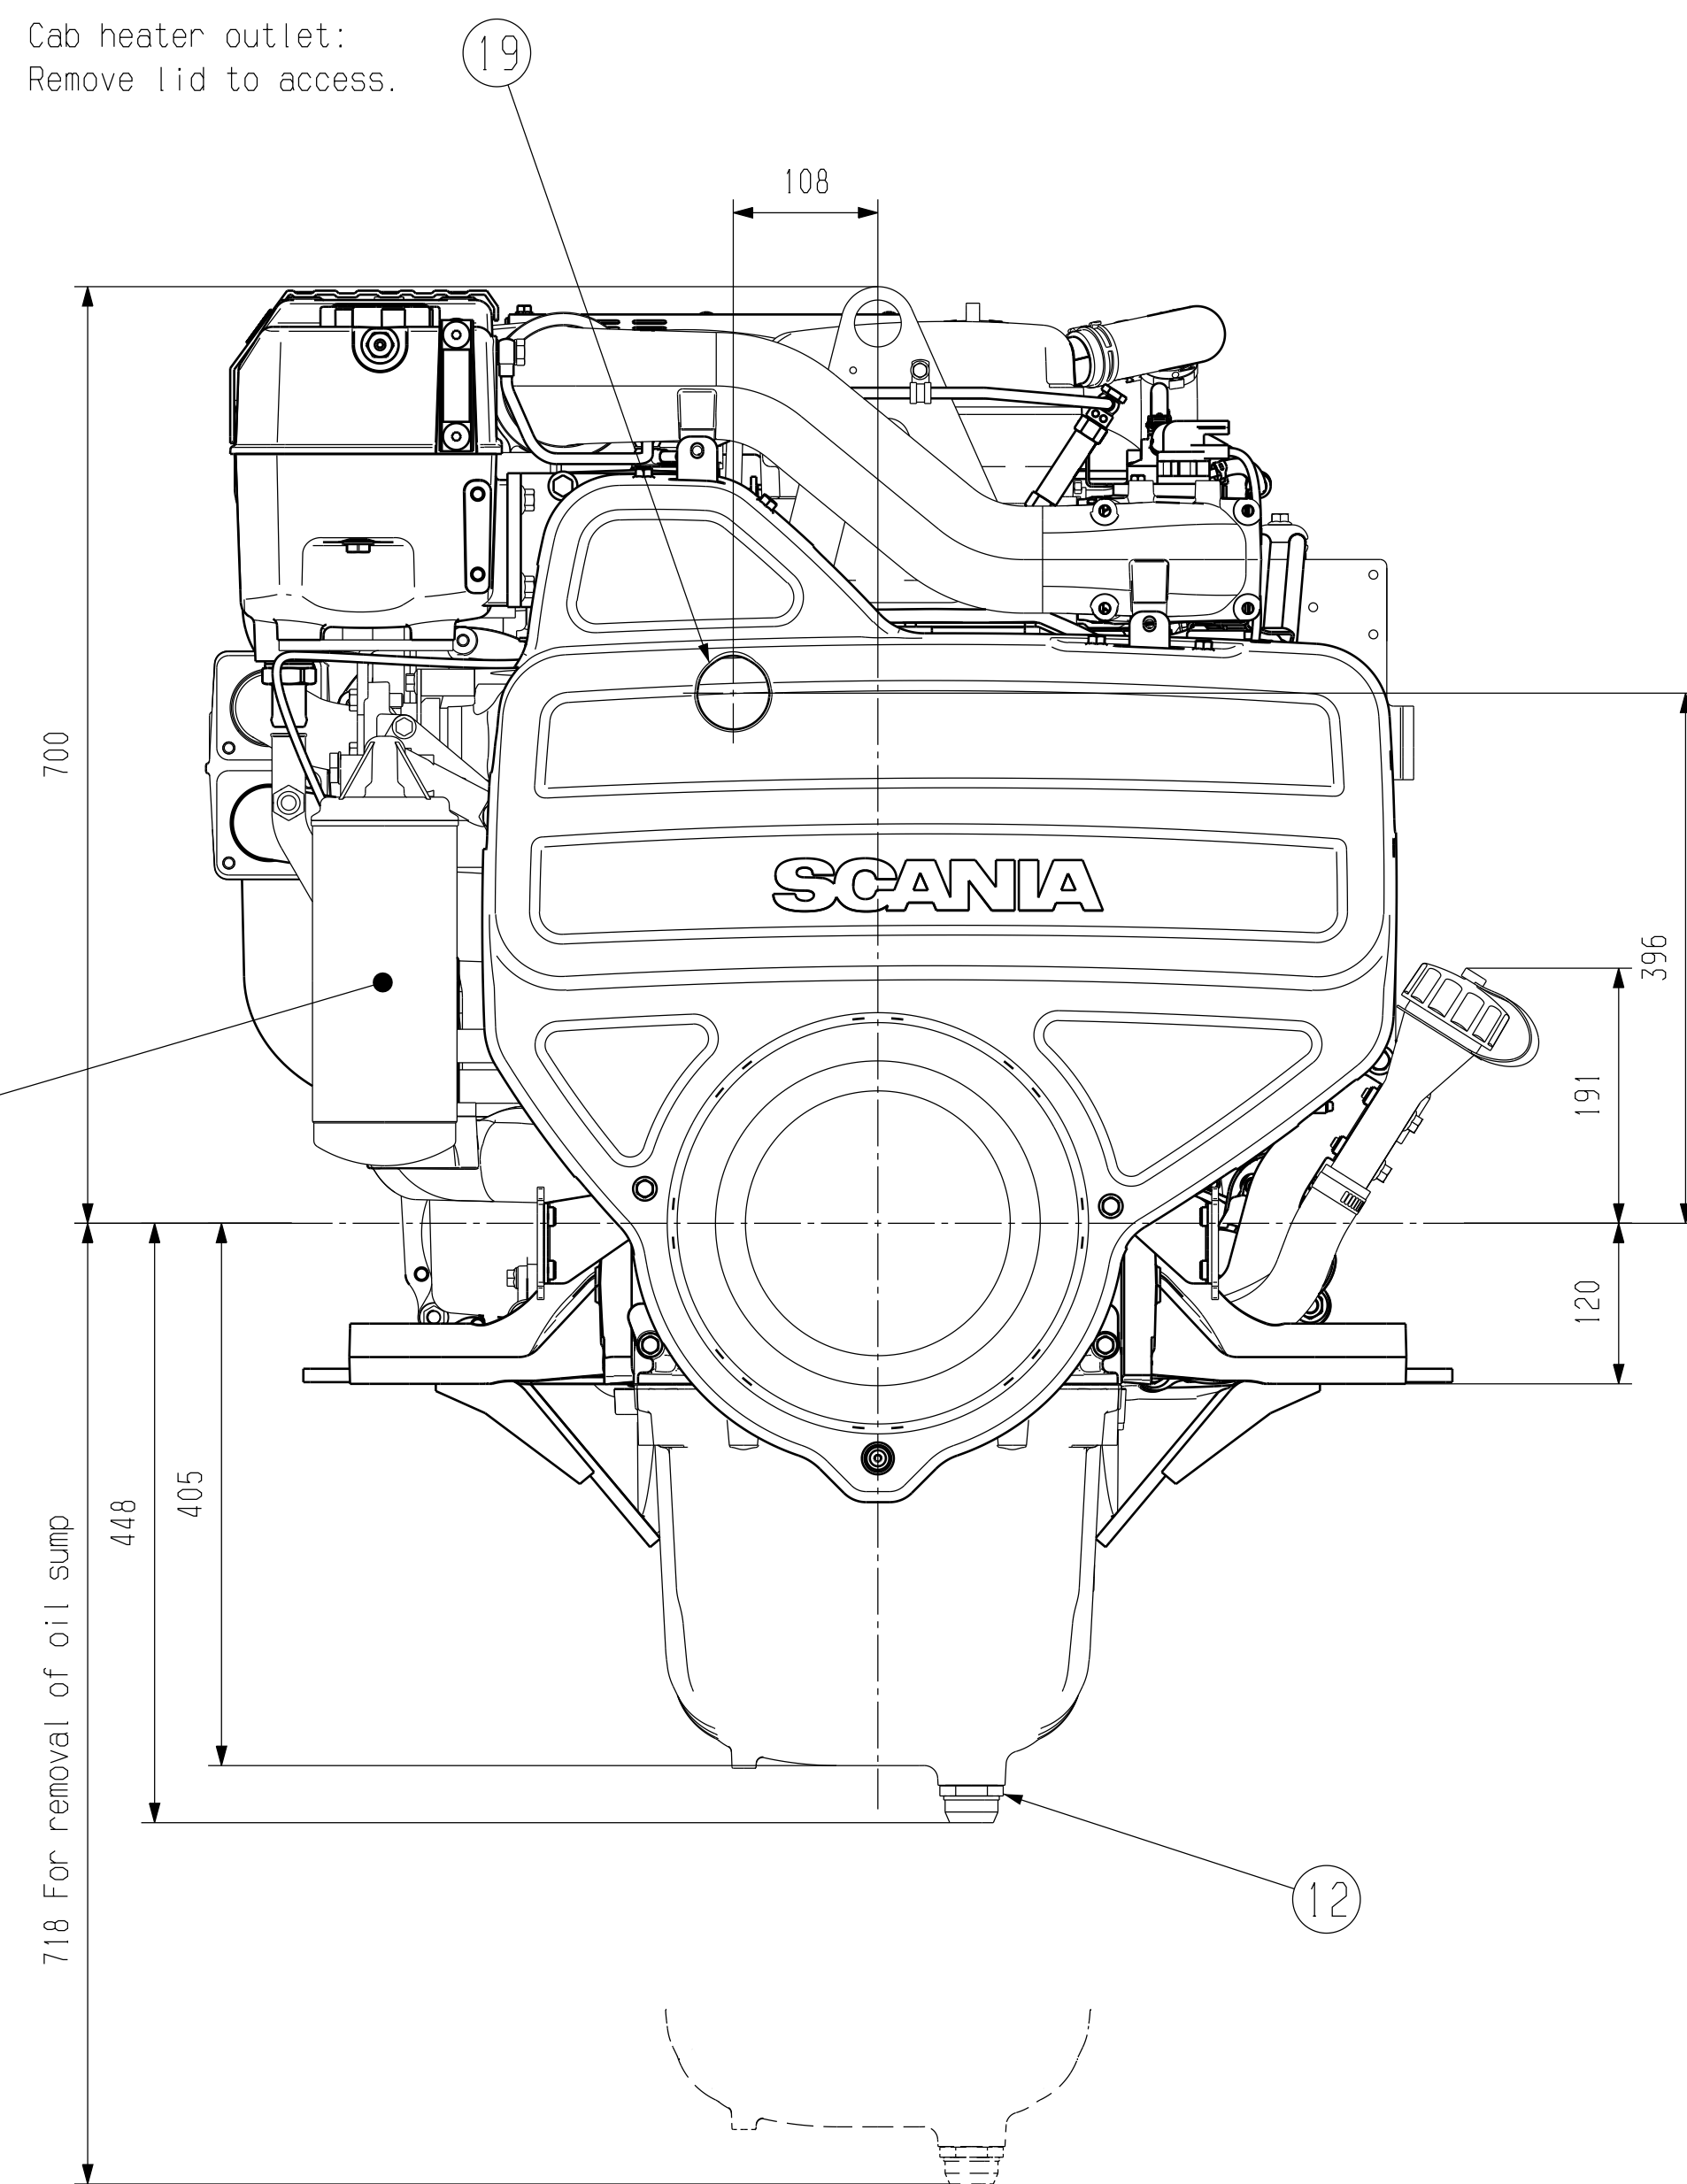
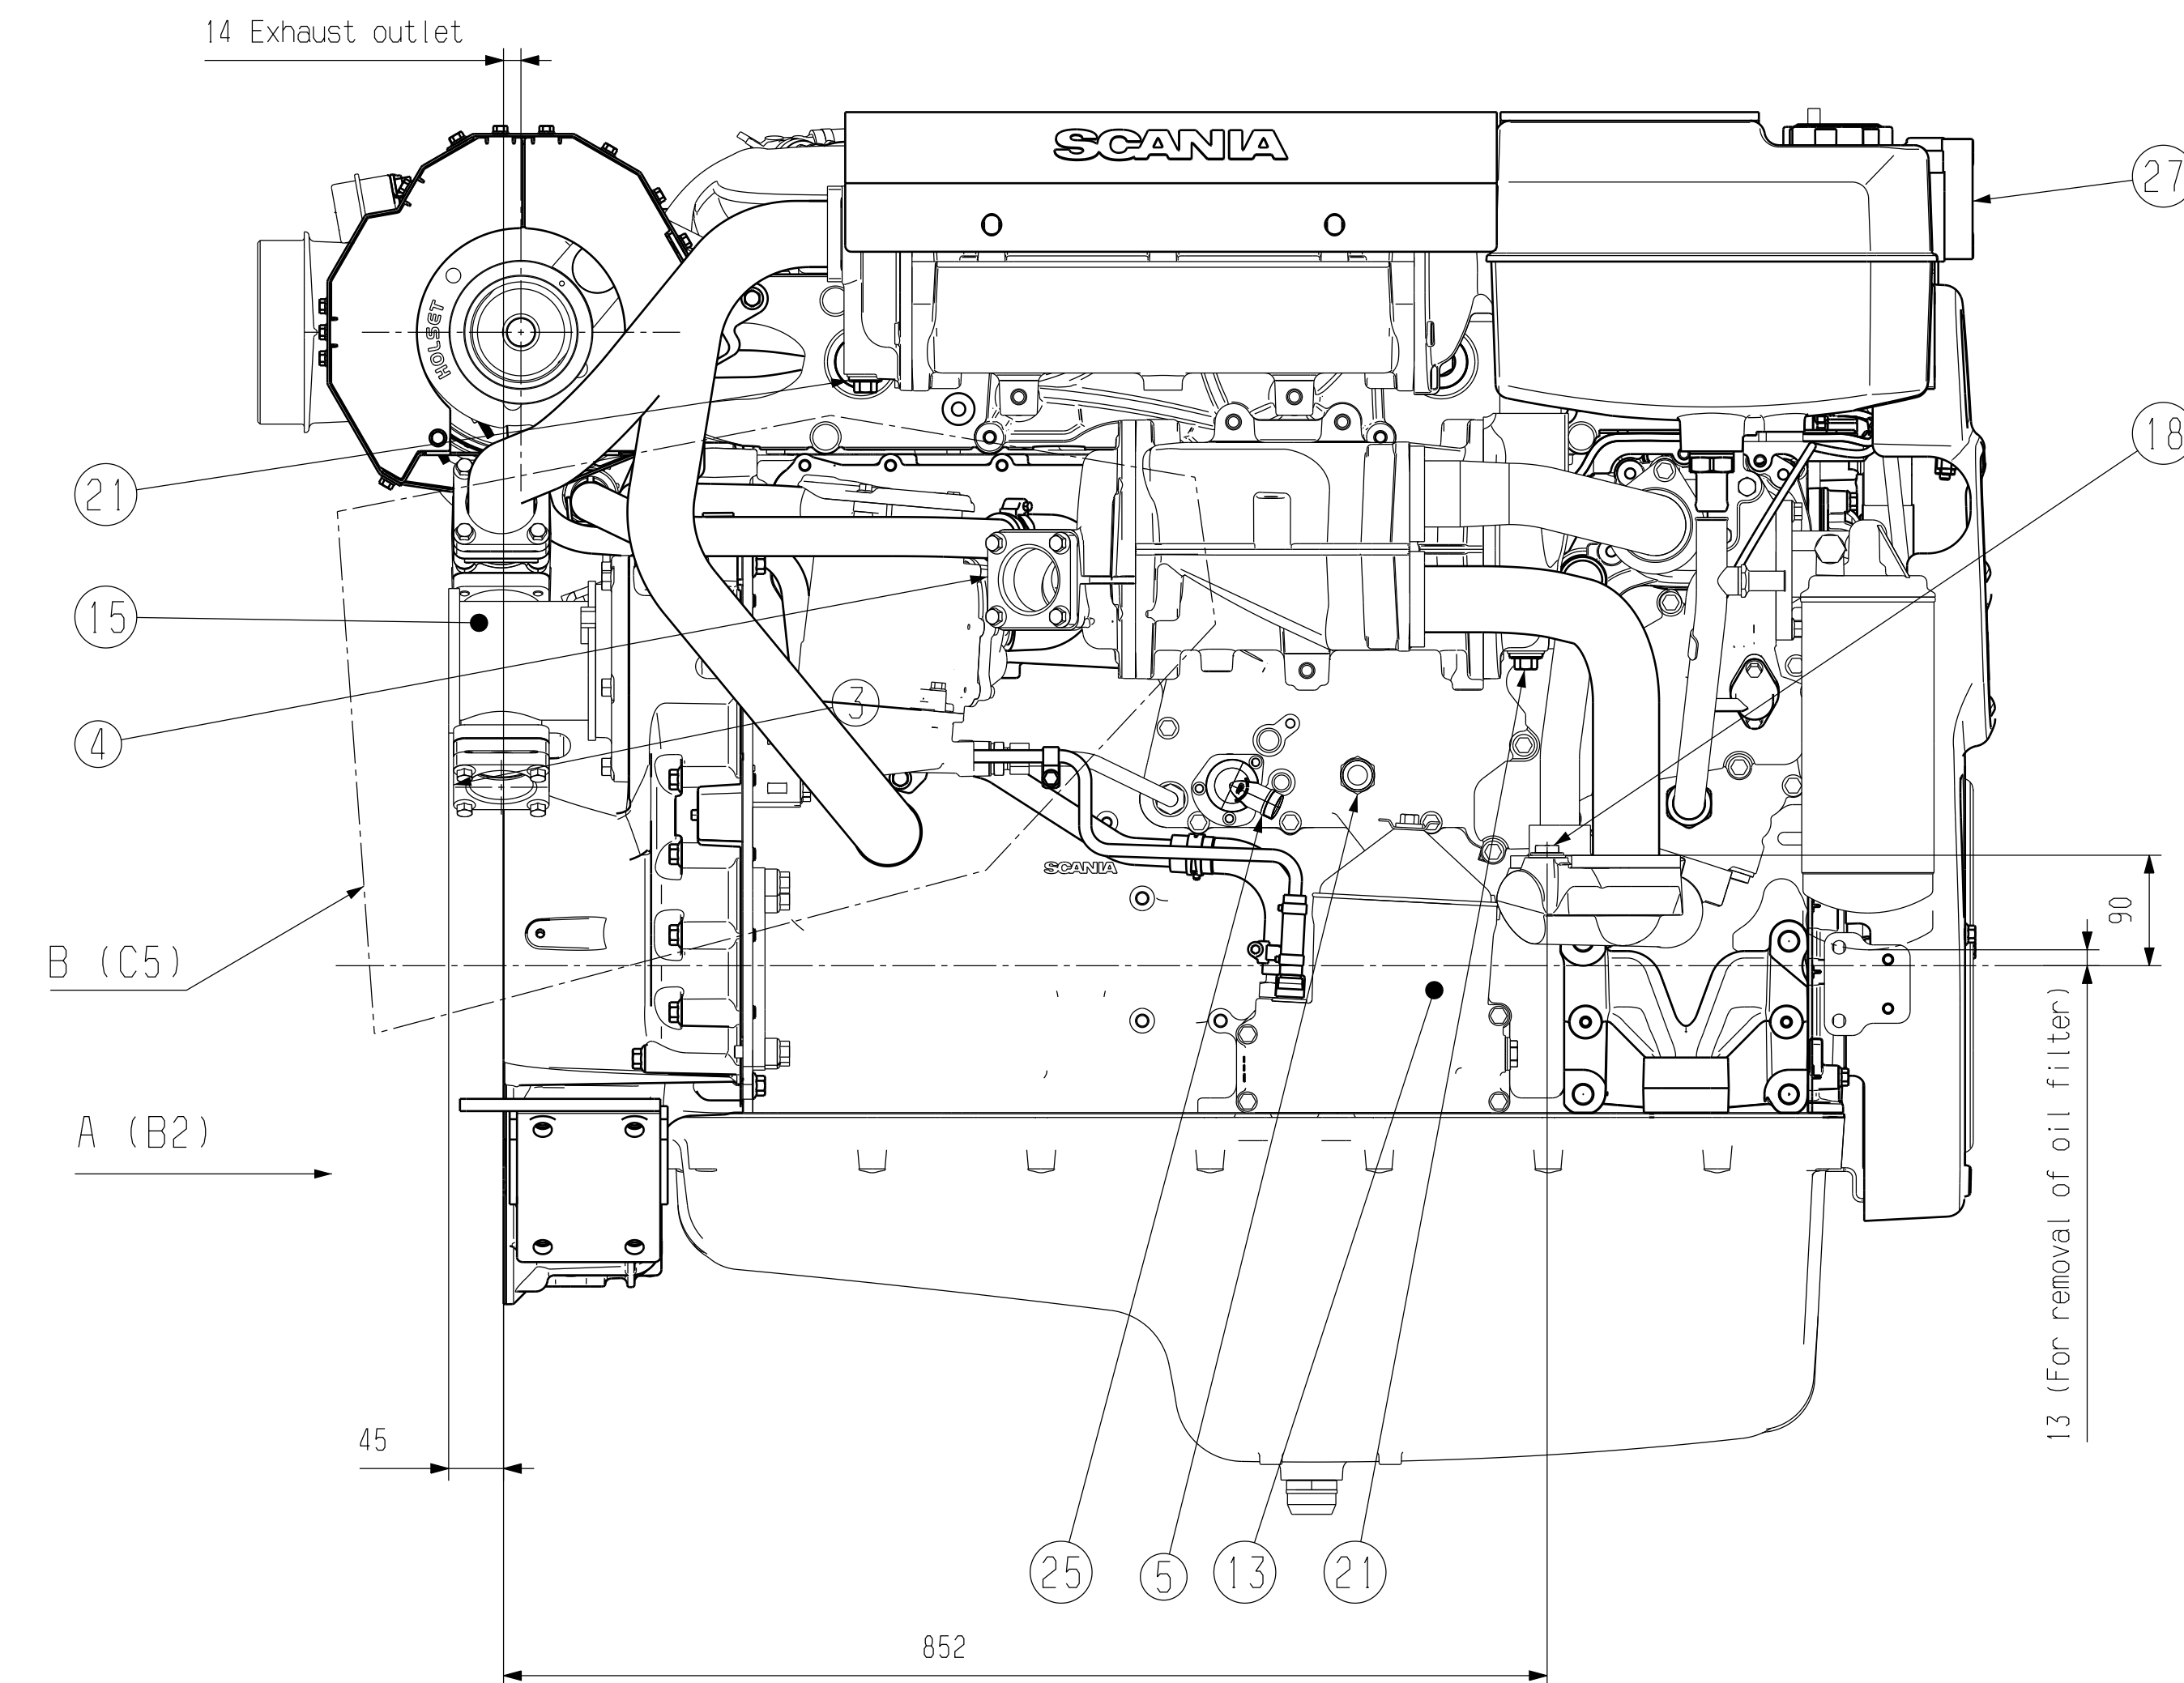
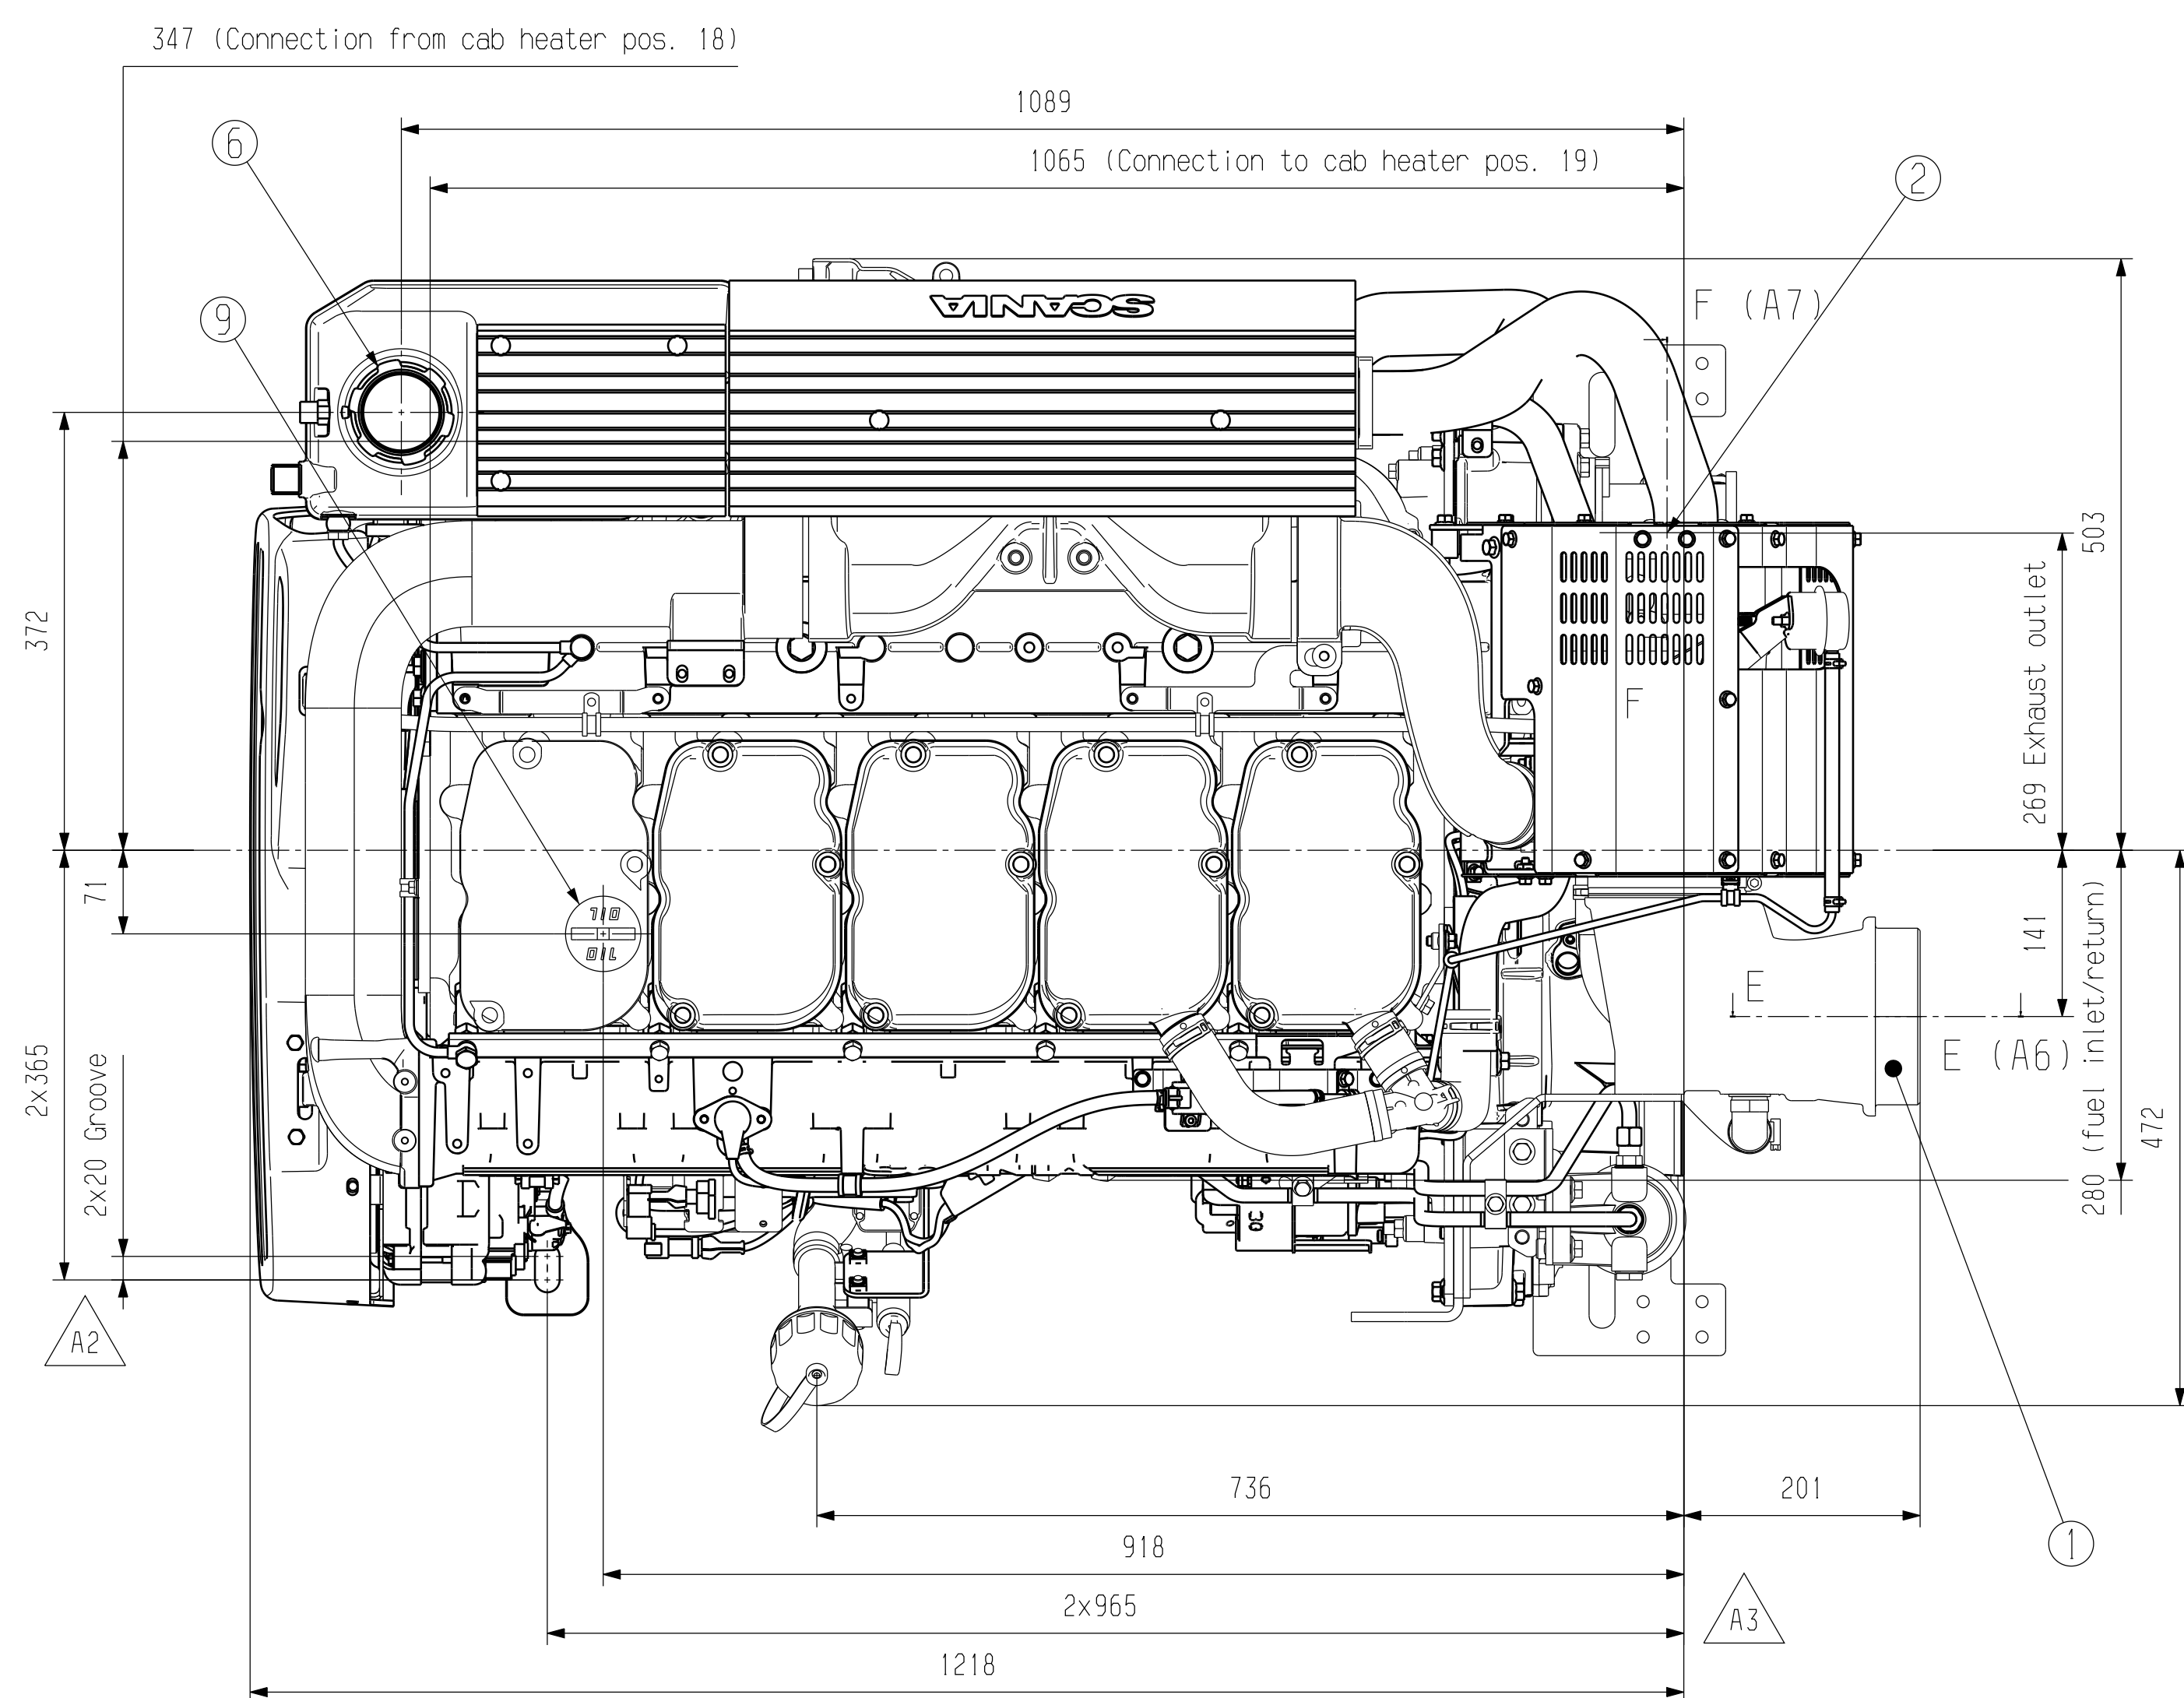
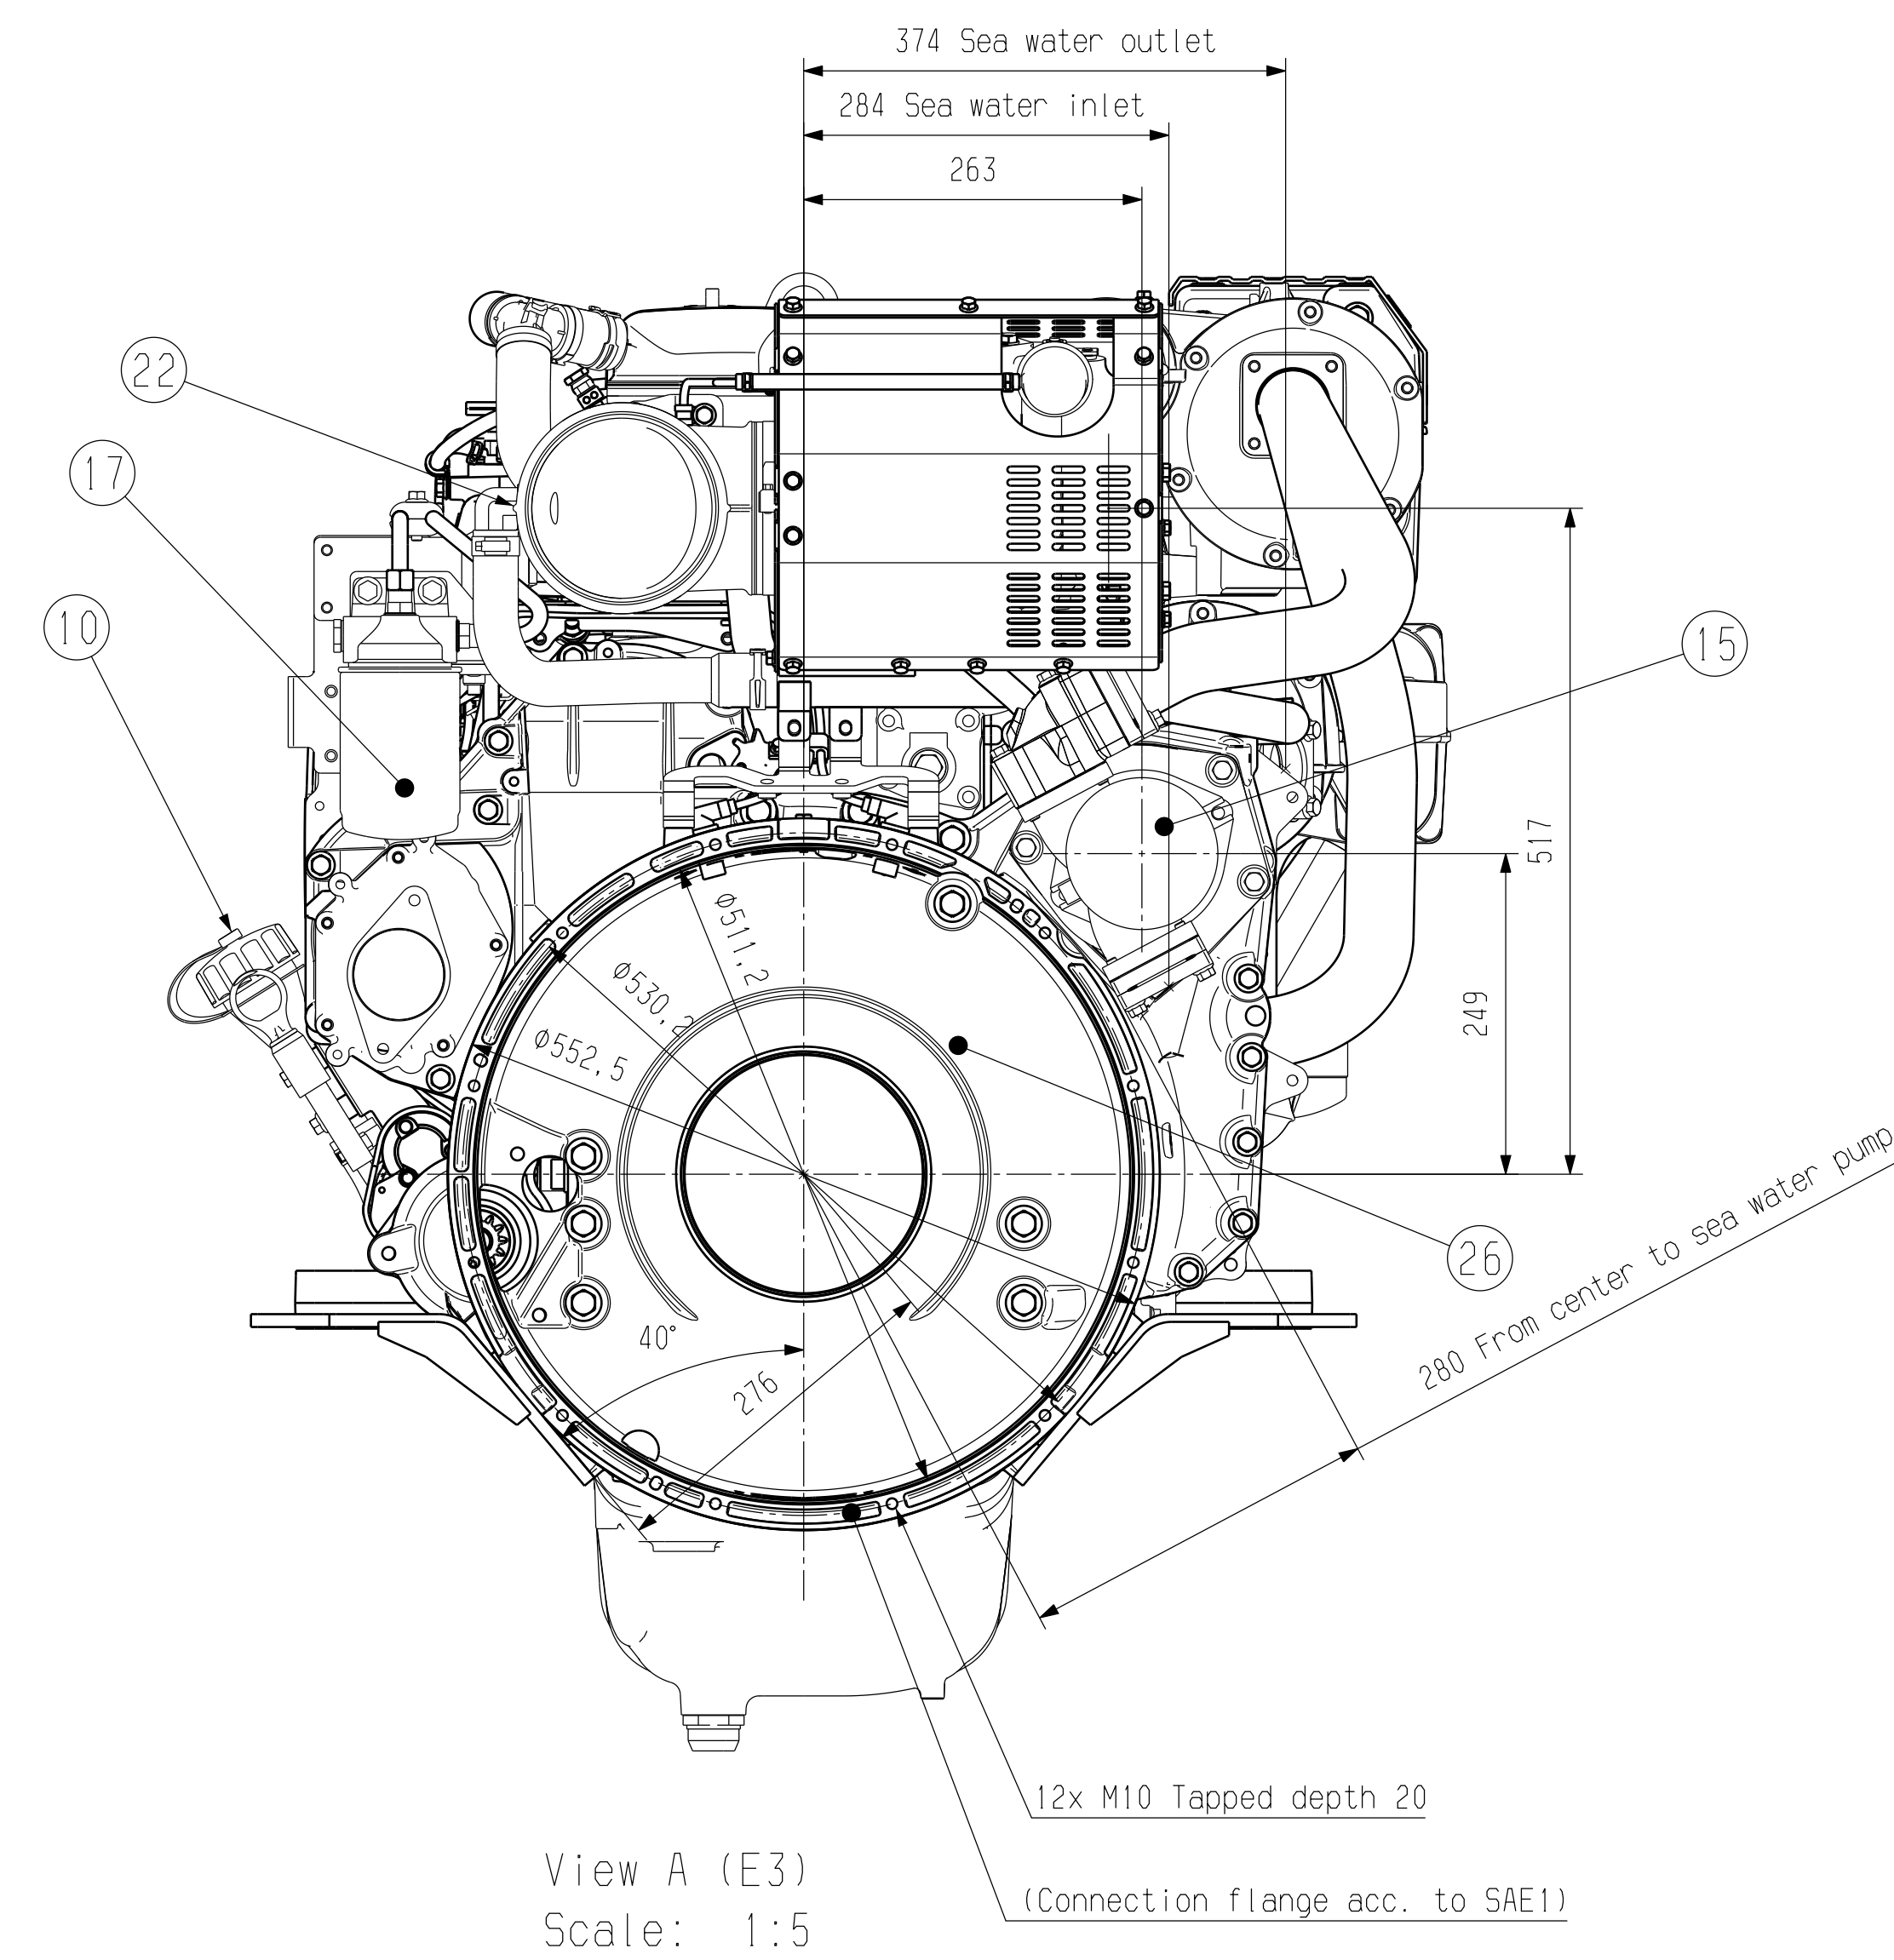
- 1 Air intake (Dia. 150)(B6)
- 2 Exhaust outlet (C6)
- 3 Sea water inlet (E3)
- 4 Sea water outlet (E3)
- 5 Coolant drain (Fresh water)(D2)
- 6 Fresh water filling (C8)
- 7 Fuel inlet (union nut M16x1.5)(E6)
- 8 Fuel return (union nut M16x1.5)(E6)
- 9 Oil filling in valve cover (C8)
- 10 Oil filling/dipstick left hand side (C3)
- 11 Oil filter (E5)
- 12 Oil drain plug (D4)
- 13 Oil centrifugal cleaner (D2)
- 14 ECU (D8)
- 15 Sea water pump (C2)
- 16 Starter motor (E6)
- 17 Fuel filter (C3)
- 18 Connection from cab heater (M22x1.5)(E1)
- 19 Connection to cab heater (M18x1.5)(F5)
- 20 Engine bracket
- 21 Corrosion bar (2x)
- 22 Air pressure sensor plug (M14x1.5)(C3)
- 23 Customer interface EMS
- 24 Diagnostics (SDP3)
- 25 Block heater (500W, 110 Volt, Supplied with 1,5m and 5m cable)
- 26 Flywheel (SEA 14")
- 27 Level marker
